KNOX MILL DAM  
ME-00276

**PHASE I INSPECTION REPORT  
NATIONAL DAM INSPECTION PROGRAM**

**AUGUST 1978**

July 18, 1978

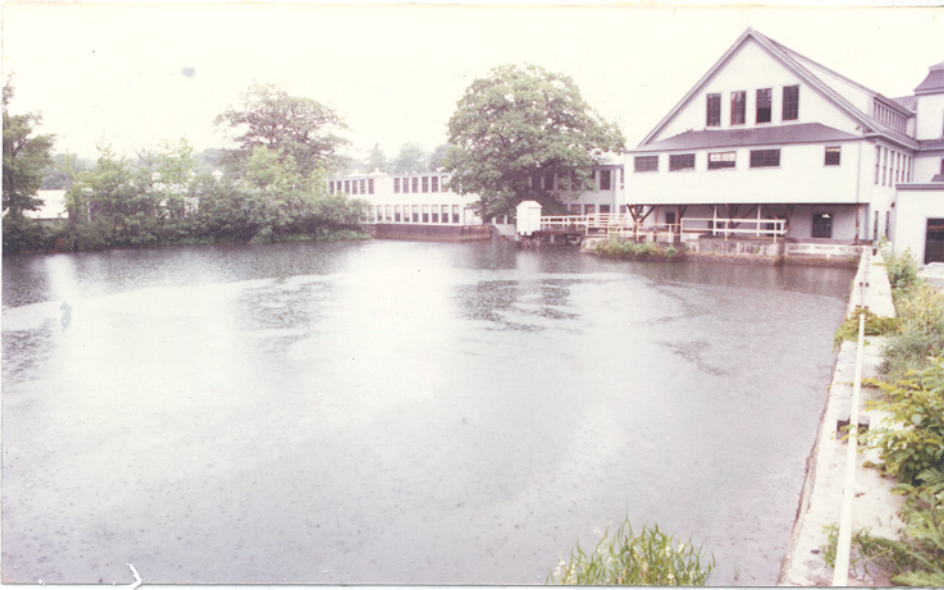
K-1

VIEW OF DAM FROM UPSTREAM

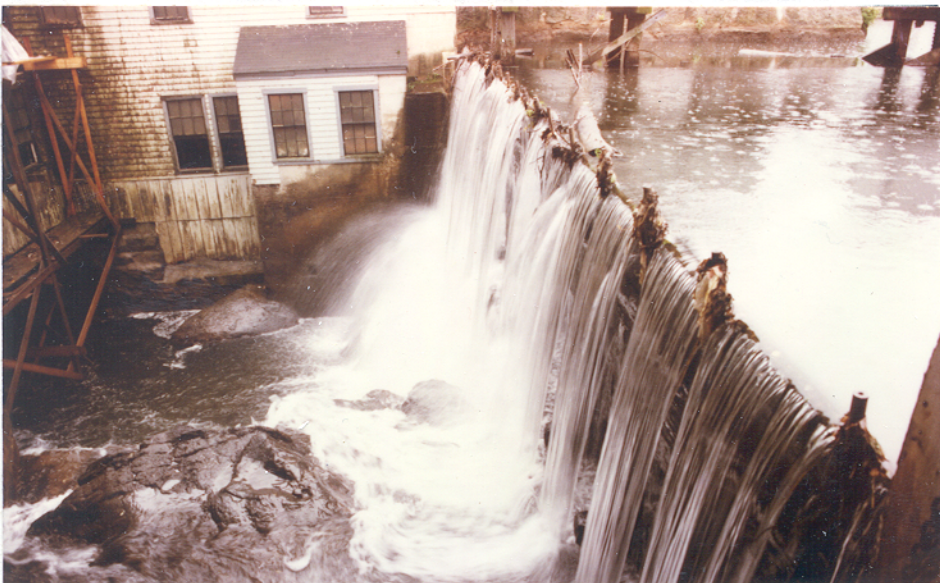
K-2

conduit beneath the Knox Mill factory has a capacity of about 2650 cfs. At a wave height of 26 feet, the water surface elevation would be about at mid-height of the second story of the factory. See photograph K-2. In the event of failure of the Knox Dam, the Knox Mill factory buildings would be substantially damaged, and there would be a great chance for the loss of many lives in the factory, unless the employees had been evacuated prior to failure. Damage downstream of the factory would be likely, though it is thought that destruction of the Knox Mill factory buildings would dissipate much of the energy from the dam failure. Thus, because of the potential for loss of life within the Knox Mill factory, the Knox Dam is classified as having a high hazard potential.

CREST OF DAM

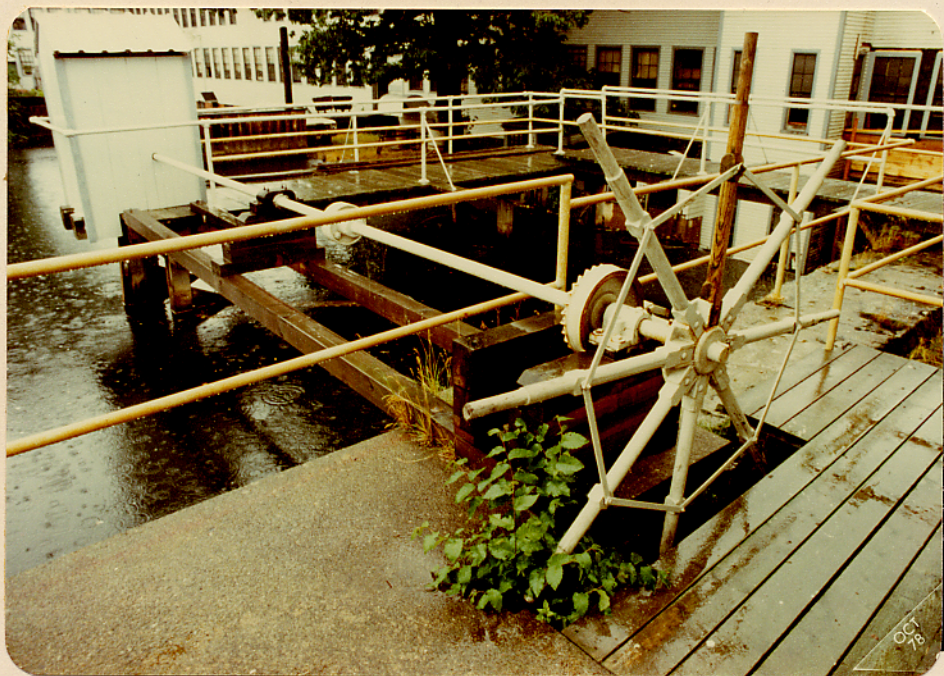
K-3

GATEHOUSE AND CONTROL WHEEL

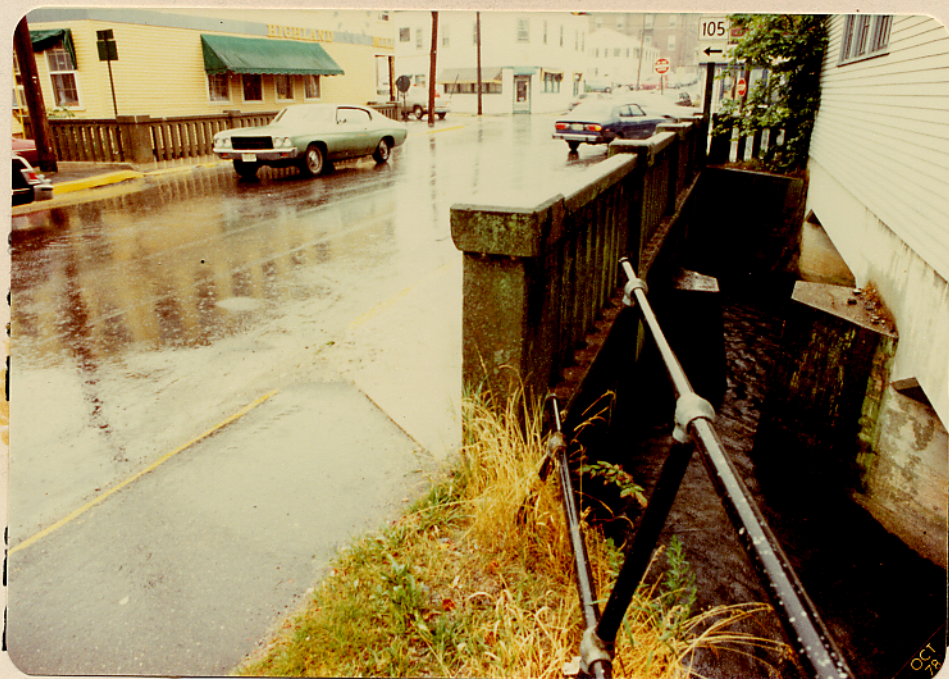
K-4

OUTLET AT DOWNSTREAM SIDE OF KNOX MILL FACTORY BUILDING

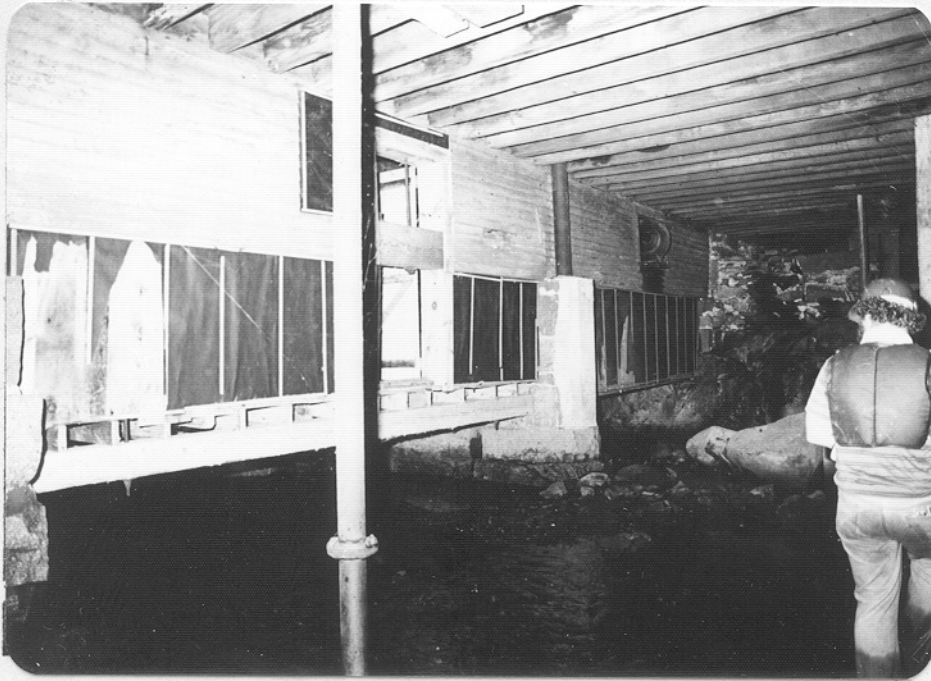
K-5

VIEW OF SHOP OVERHAND IN NUMBER 1

SLUICEWAY UNDER KNOX MILL

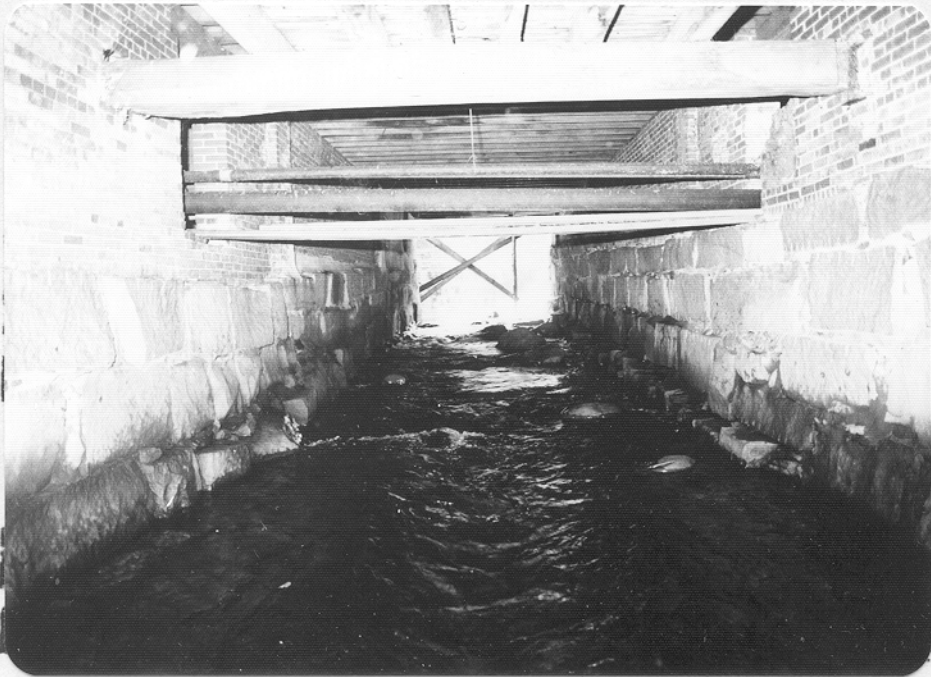
K-6

VIEW OF NUMBER 2 SLUICEWAY UNDER KNOX MILL

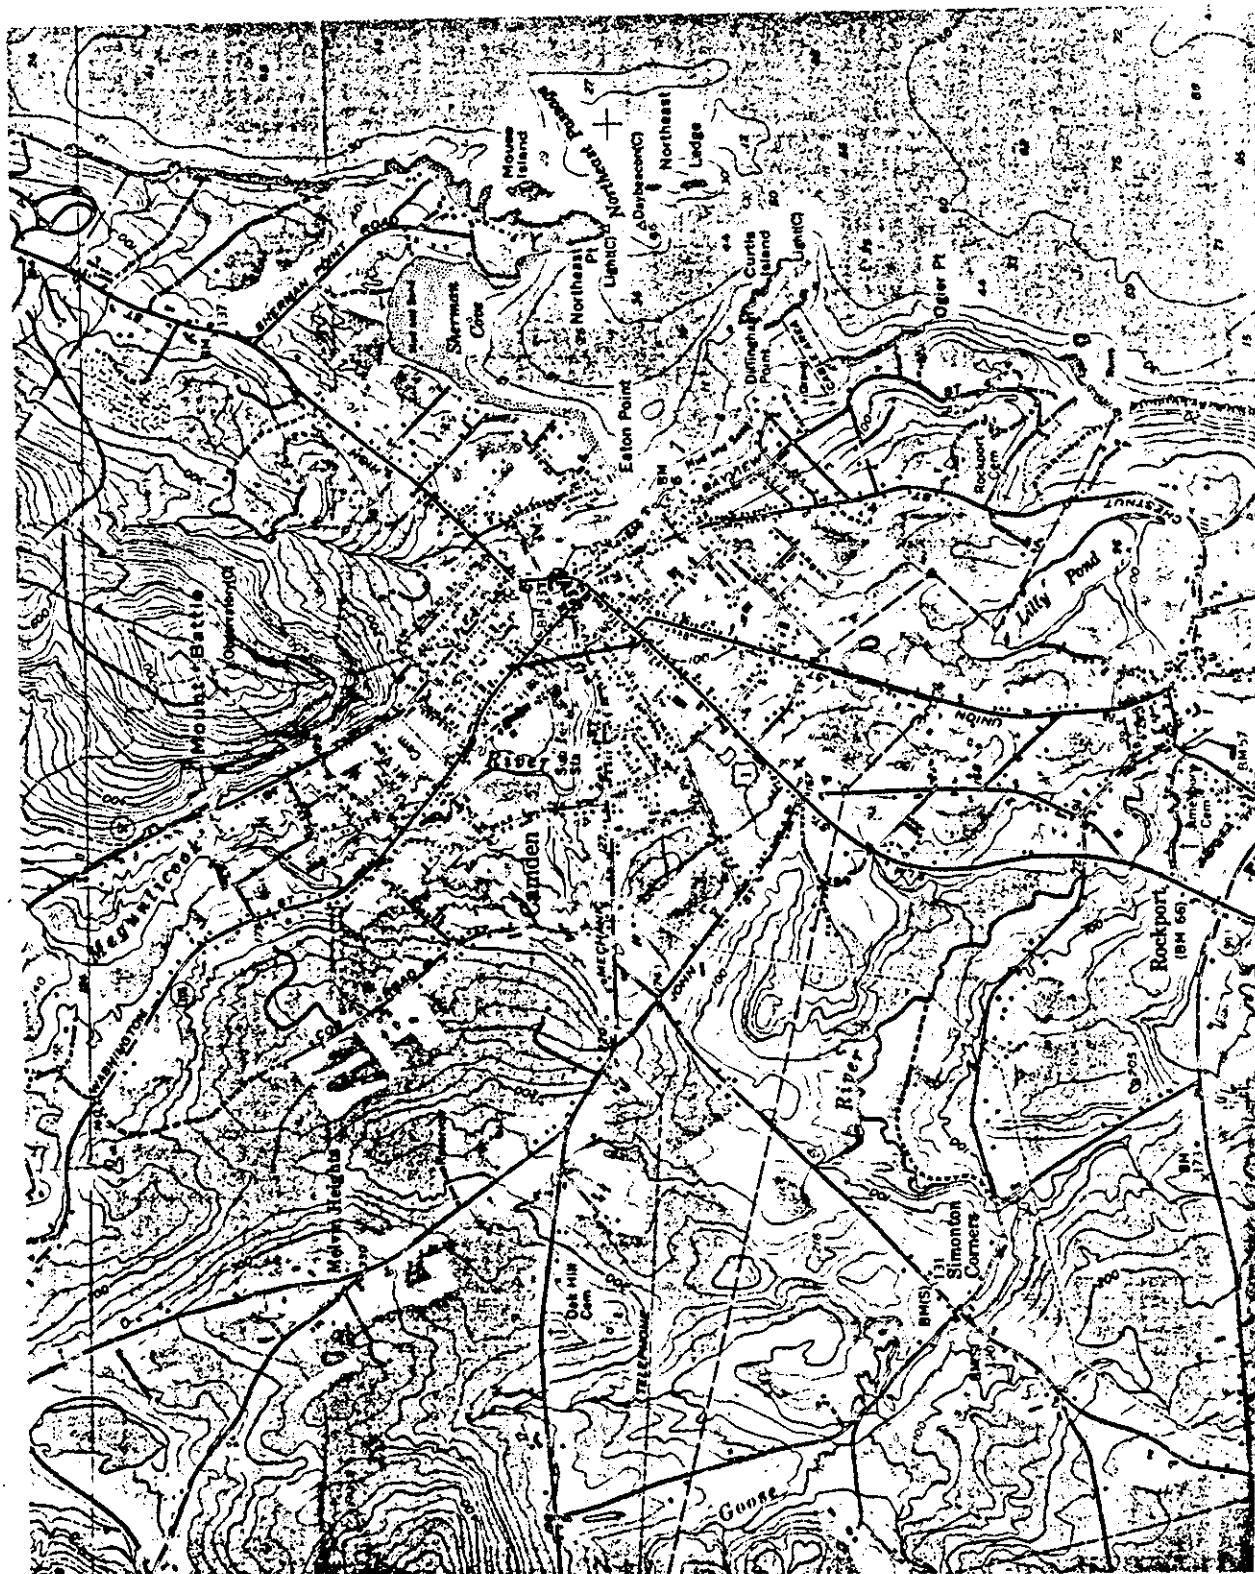
PROJECT FAILURE OF SOUTH WING WALL	COMP BY BTB	JOB NO. 2050304
	CHK BY CAB	DATE 8-30-78

There is a possibility of failure of the south wing wall of the dam. This possibility was examined according to rule of thumb methods as described in an attachment to ETL 1100-2-234. If the south wing wall failed at a Knox Mill Pond elevation equal to full spillway, there would be sheet flooding of about 1 foot in depth in a 500 foot wide flood plain between Knox Mill and the ocean. Some damage to property would occur. Should the north wing wall be breached by flood flows, these flows would be encompassed by the Knox Mill building complex.

SINCE  $Q_{ps}$  from a breaching of the south wing wall is 1460 CFS and 1' of depth of flow will conduct a flow of about 3850 CFS, it may be concluded that sheet flow through the streets of Camden to the ocean would occur if the south wall were breached. There would be damage in the flood plain.

1. A system to prevent erosion and provide support during overtopping flows downstream of the south masonry wing wall along the section parallel to Mechanic Street.
2. A designed-to-fail flashboard system should be developed and implemented for the spillway of the Knox Dam. If such a system is used, the spillway capacity will be increased by almost 40 percent during flood flows when the flashboards collapse. This increase in spillway capacity would lessen the frequency of overtopping of the wing walls of the dam.
3. Enlargement or alteration of the spillway to improve the discharge capacity at the dam.
